SANTA PAULA CREEK PERCOLATION: AN UPDATE

United Water Conservation District
Open-File Report 2013-02
February 2013

UWCD OPEN-FILE REPORT 2013-02

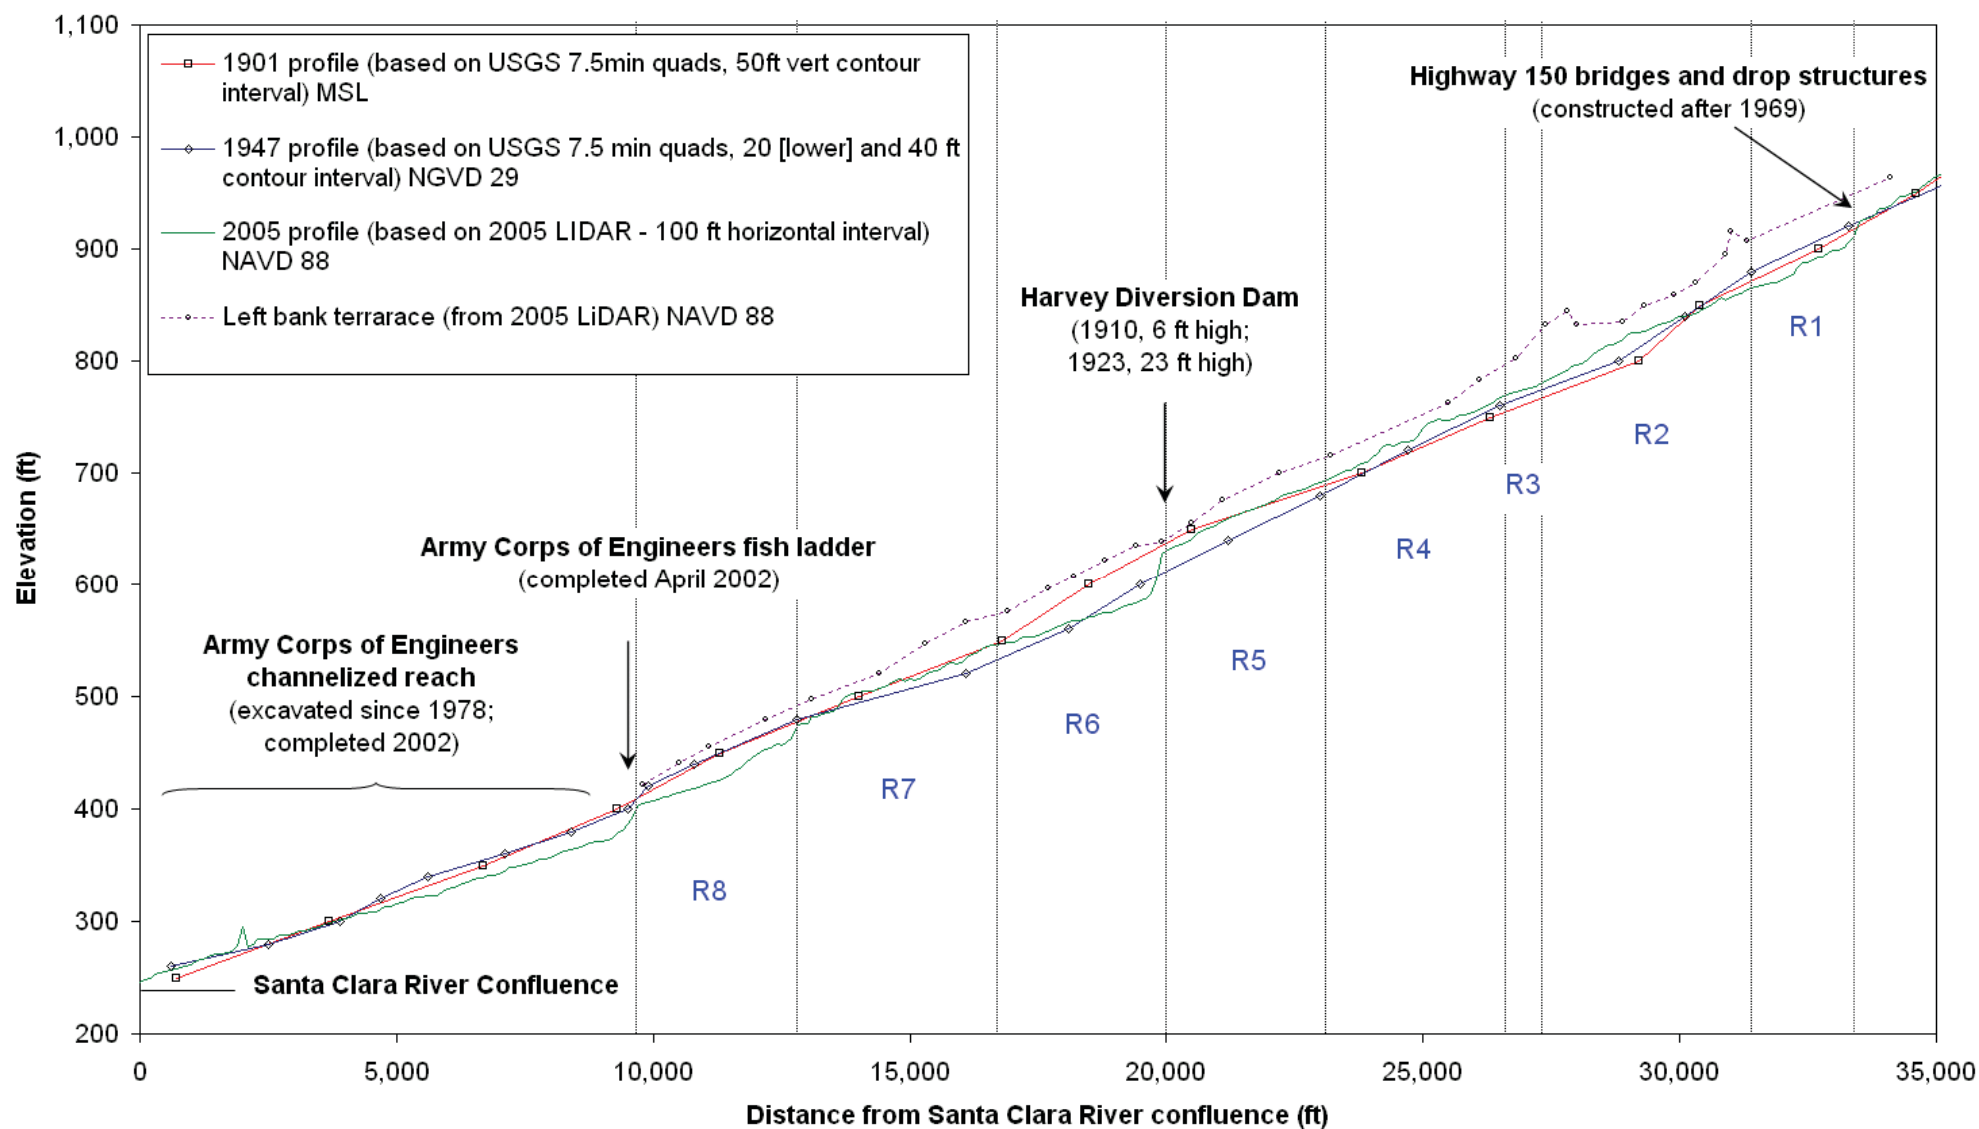
Figure 7.

Longitudinal profiles (1901, 1947, and 2005) for Santa Paula Creek from the Highway 150 bridge to the confluence with the Santa Clara River. (Stillwater Sciences, 2007b)

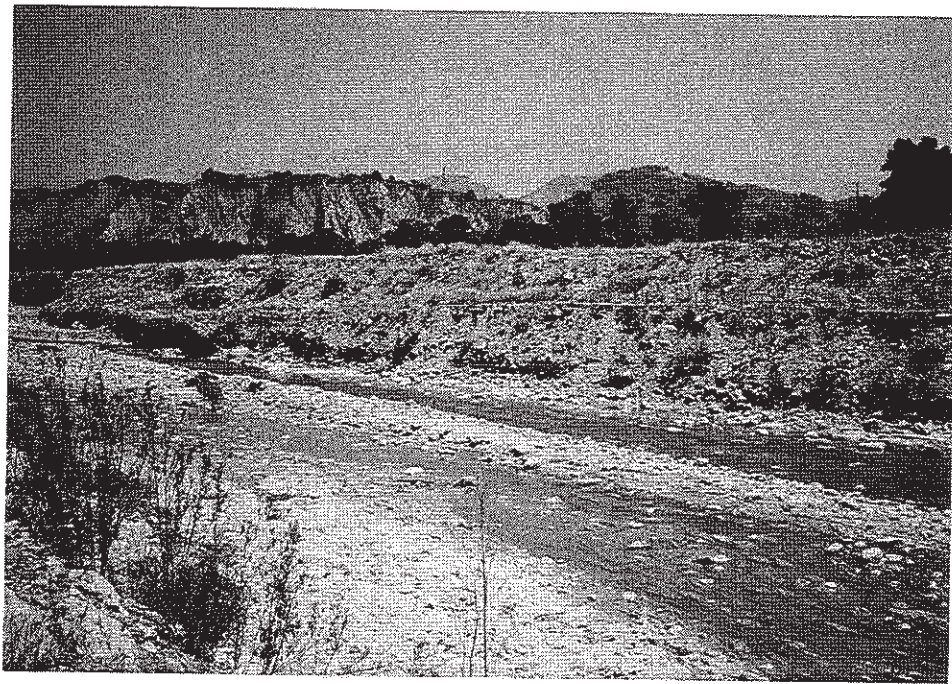
Photo. No. 13. This is a view of the typical channel bottom and bank in the reach upstream of the railroad bridge. June 1992

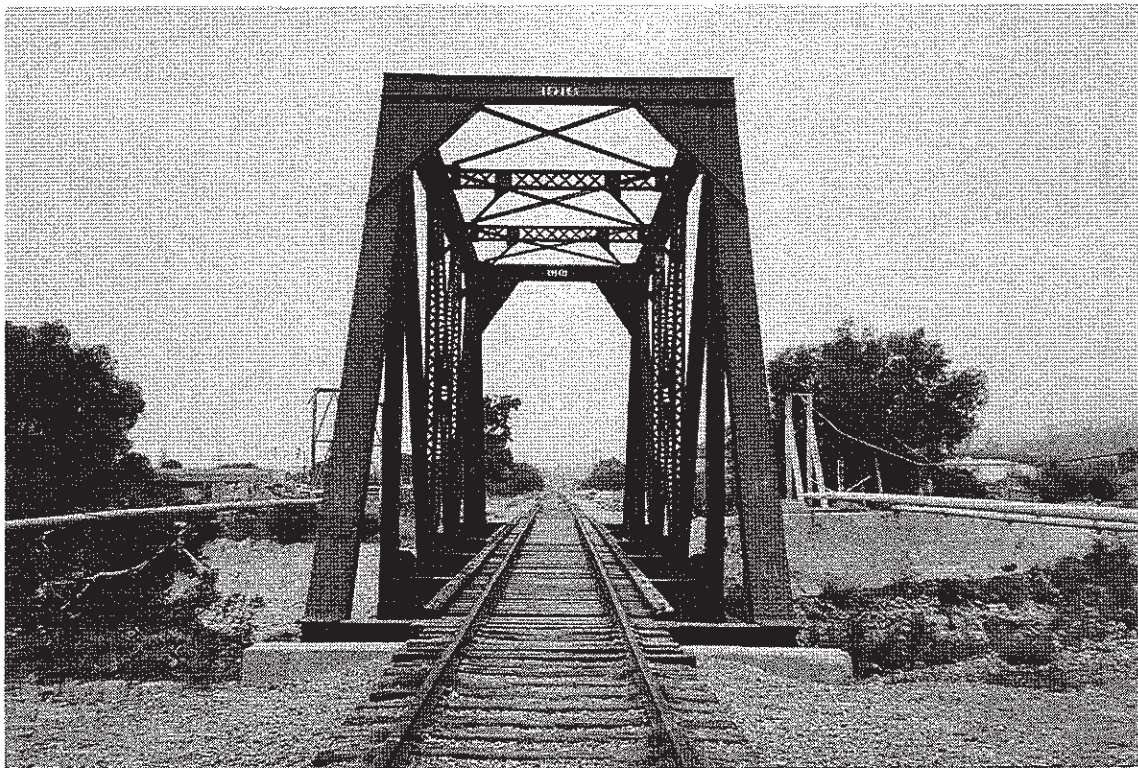
Photo. No. 14. This view shows the three pipelines that need to be relocated. Texaco's 8-inch crude oil pipeline is located to the left (downstream) of the bridge. The first pipeline to the right (upstream) of the bridge is the 10-inch gas line owned by Shell Pipe Line Corporation and next to it is the 8-inch crude oil pipeline owned by Unocal. (June 1994)

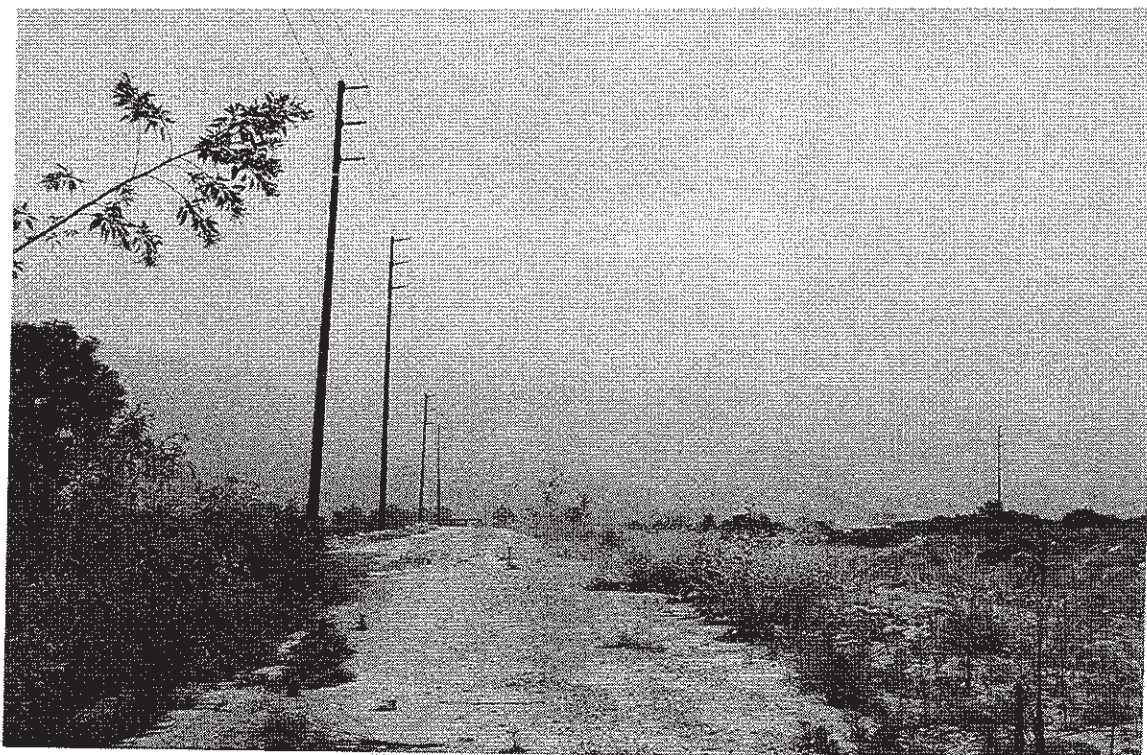
Photo. No. 15 & 16. This view is looking downstream toward the railroad bridge that shows the utility poles that would require relocation. (June 1994)

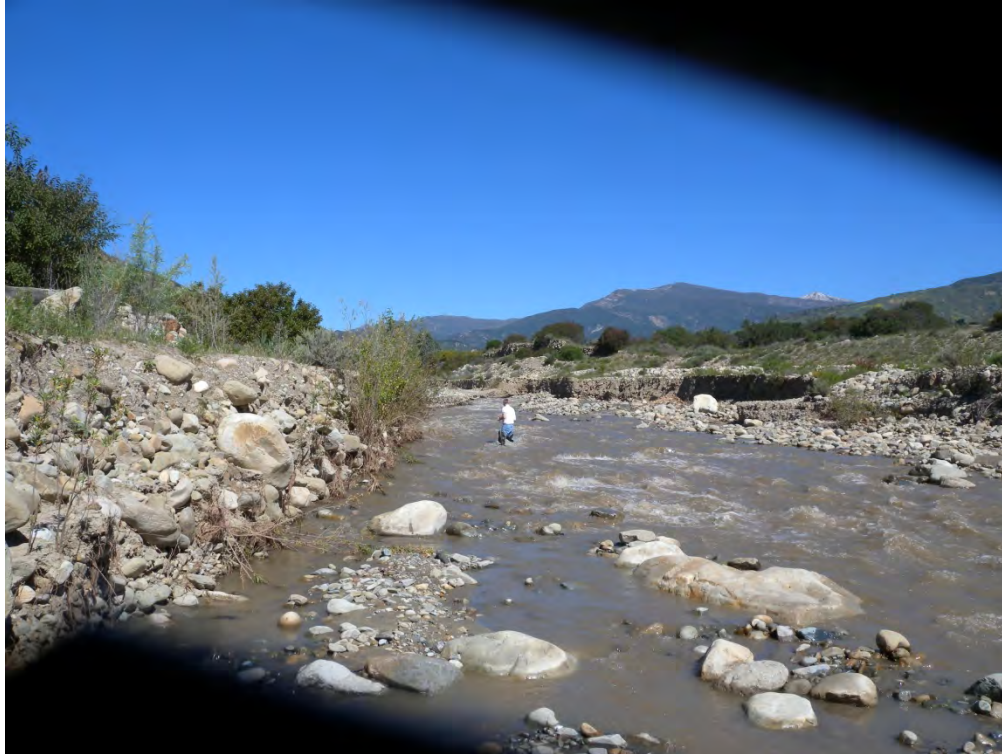
Upstream location, looking upstream towards Bridge Road. Flow measured at 199 CFS on April 1, 2011

Recent measurements of flow in lower Santa Paula Creek are shown in Table 1. The records show that on April 1, 2011 flow near Bridge Road was nearly 199 cfs, and flow below Harvard Blvd. was about 192 cfs. These records indicate percolation of 6.4 cfs, or just 3.2 percent of the flow in the creek. On May 26, 2011, measured flow along the same reach diminished from 17.7 cfs to 16.8 cfs, indicating percolation of less than one cfs. The remaining UWCD measurements from 2011 and 2012 show small gains in flow between the two stations. Gains of nearly five cfs were measured on two dates in April 2011, when upstream flows near Bridge Road were measured at 64 and 42 cfs.

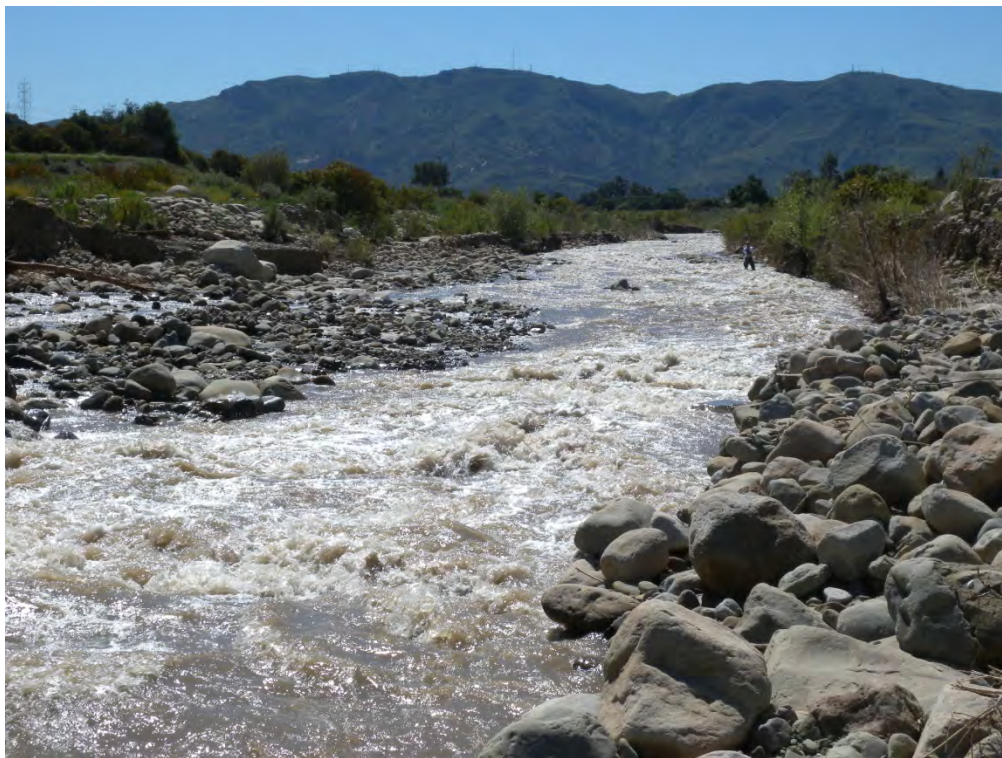
Upstream location, looking downstream. Flow measured at 199 CFS on April 1, 2011

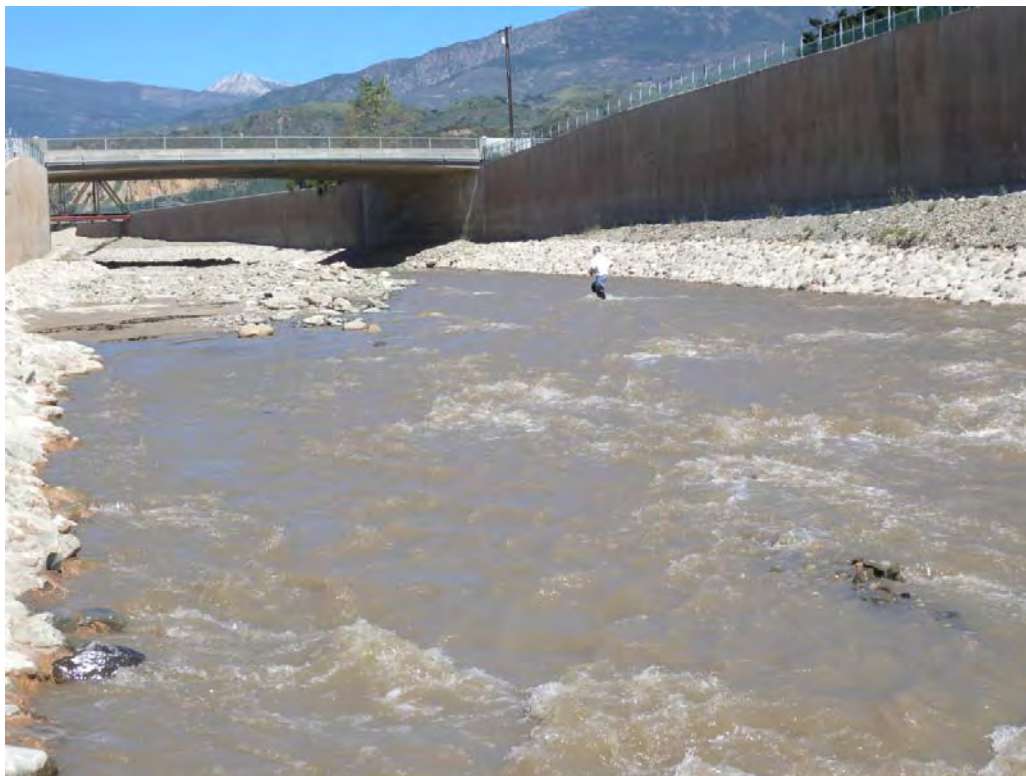
Downstream location, looking upstream on April 1, 2011. Flow measured at 192 CFS.

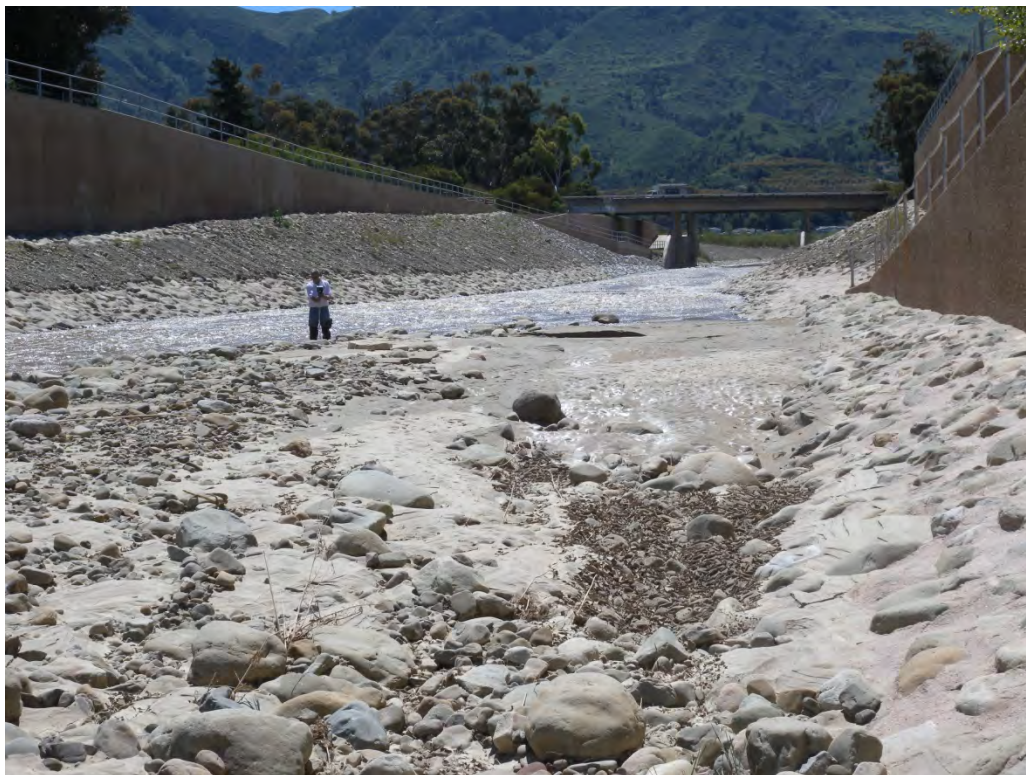
Downstream location, looking downstream on April 1, 2011. Flow measured at 192 CFS.

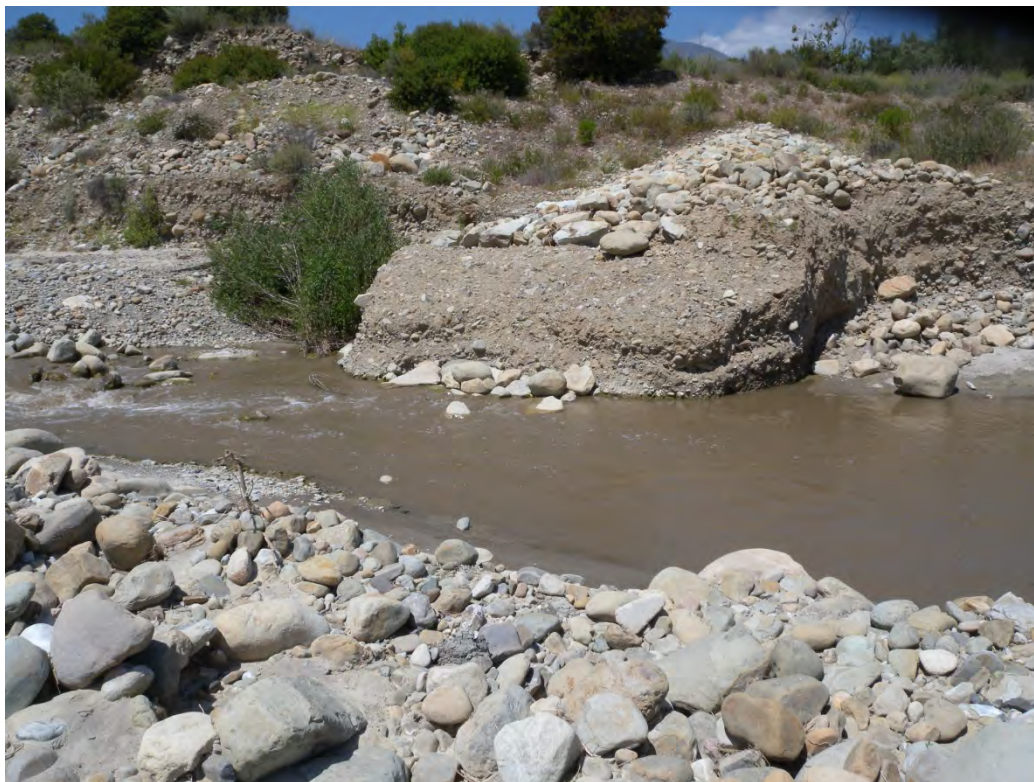
Upstream location on May 26, 2011. Flow measured at 18 CFS.

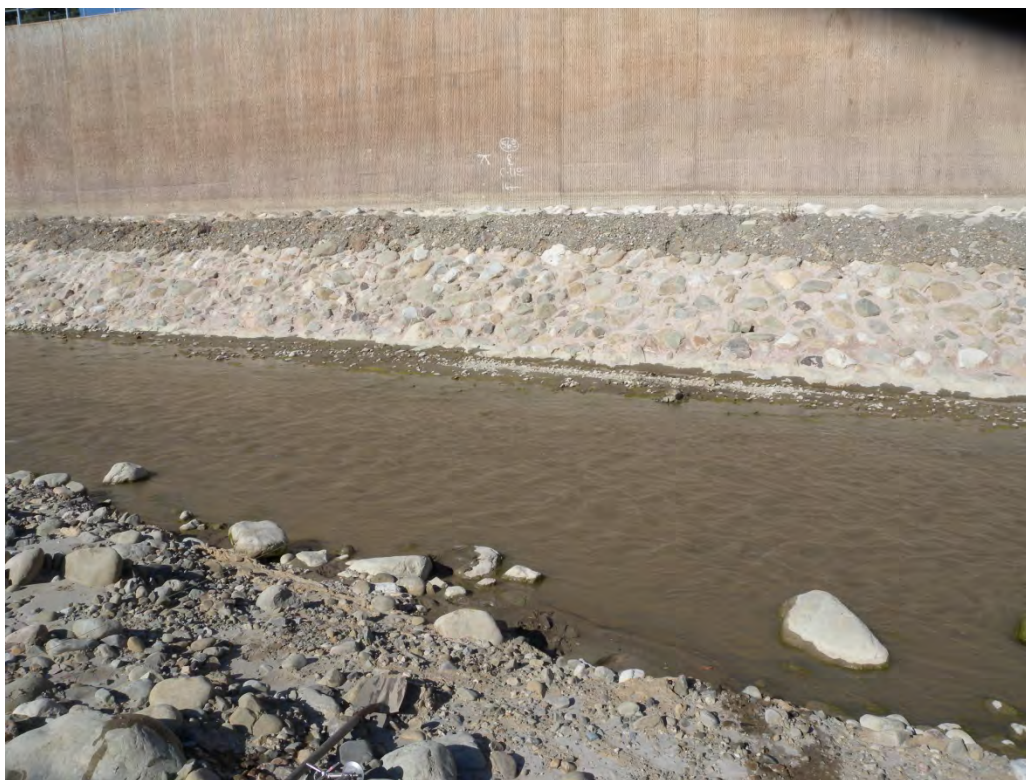
Downstream location on May 26, 2011. Flow measured at 17 CFS.

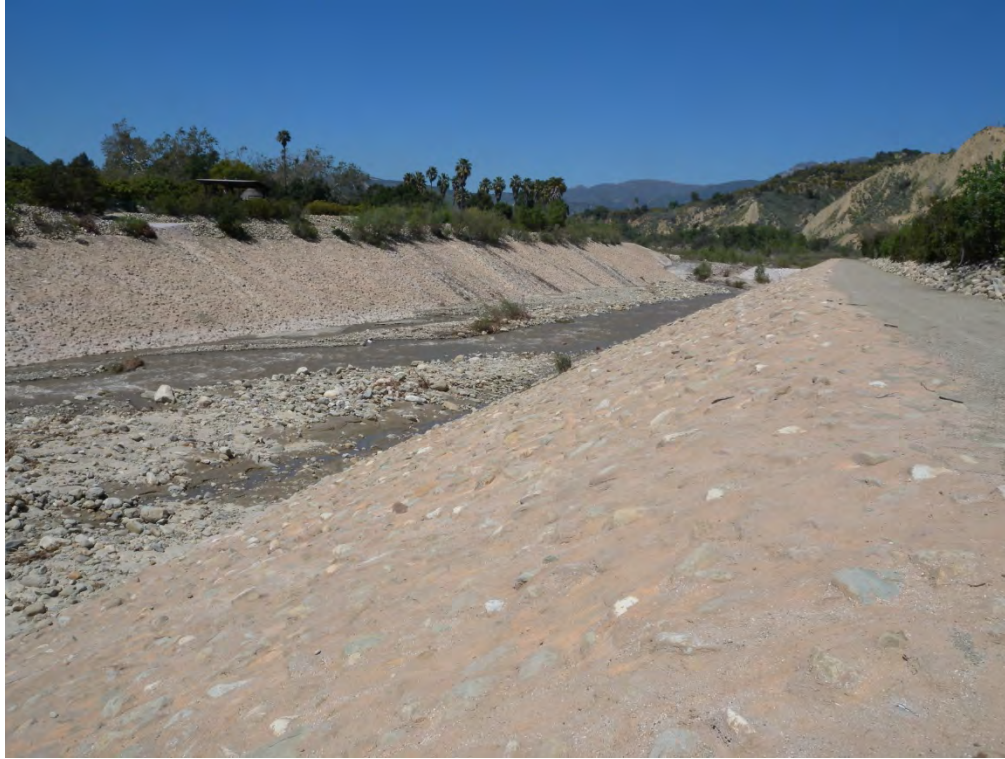
Santa Paula Creek channel, looking upstream near Wilson Ranch on April 1, 2011. Note seeps along the west side of the channel.

Seeps are sometimes observed along the west bank of the creek in the area below the COE fish ladder. Seepage from shallow perched zones along the creek contribute minor inflow to the creek (see shallow groundwater discussion, next section). Flow measurements were not conducted up- and down-stream of the reach where seepage is observed, as observed flow is small and intermittent. Photographs of the seeps are included in the Appendix.

Along the west bank of Santa Paula Creek, in the area below the COE fish ladder, a number of seeps can be observed along the grouted rock that forms the side of the channel. Several seeps are located adjacent a surface water reservoir (pond) located within 50 feet of the embankment of the flood control channel, with seeps extending about 300 feet downstream from the reservoir location (Figure 5). The reservoir is on the Wilson ranch, and believed to receive water delivered from the Harvey Diversion some distance upstream. Increased flow in these seeps is commonly observed following irrigation events at the Wilson ranch (personal communication with landowner Chris Wilson, October 2012). The observed relationship between irrigation adjacent the creek and increased flow in the seeps along the west side of the constructed channel suggest shallow units of low permeability that serve to produce localized perched water table conditions in this vicinity.
